CHASES POND DAM
ME 00188

PHASE I INSPECTION REPORT
NATIONAL DAM INSPECTION PROGRAM

APRIL 1980

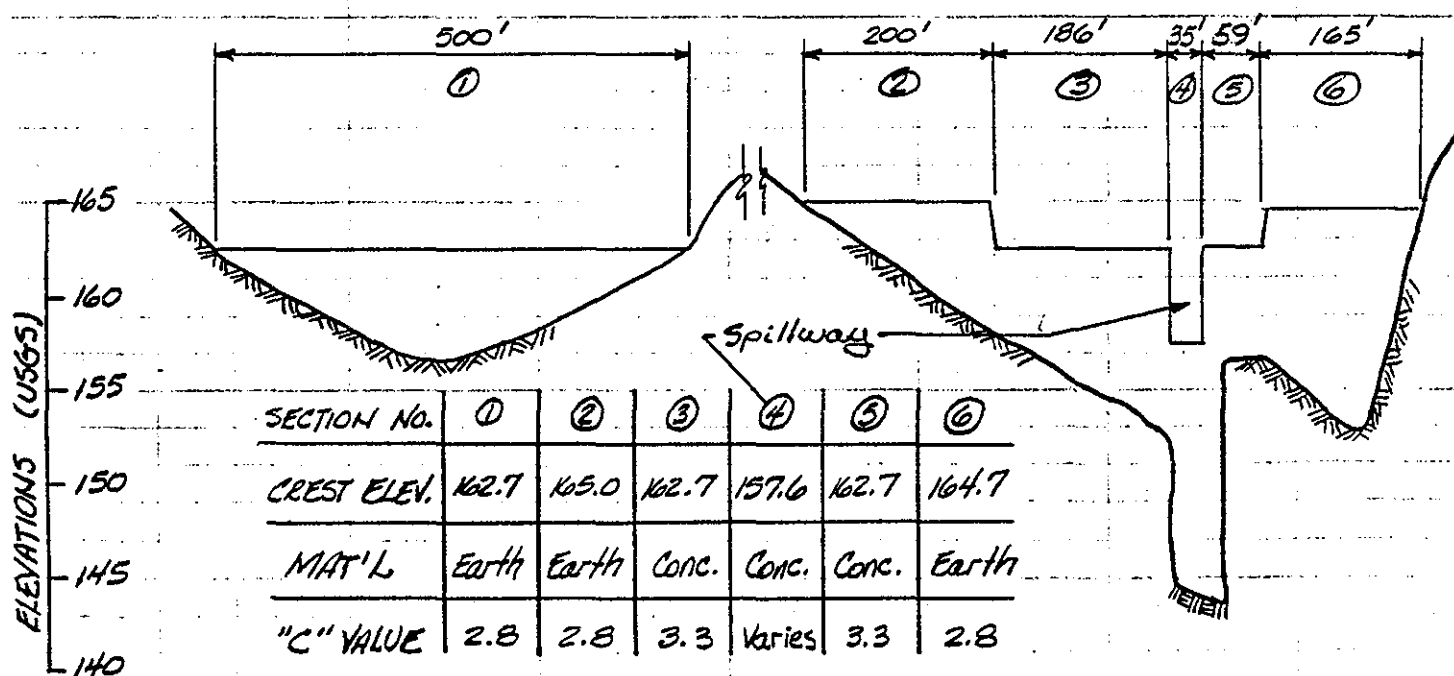
ELEV. VIEW OF DAM AND DIKE LOOKING U/S

W.S. ELEV.	SECT. ① L = 500 ft. C = 2.8 Q ₁ (cfs)	SECT. ② L = 200 ft. C = 2.8 Q ₂ (cfs)	SECT. ③ & ⑤ L = 245 ft. C = 3.3 Q _{3.5} (cfs)	SECT. ④: SPILLWAY 35 ft. Conc. Qgee		SECT. ⑥ L = 165 ft. C = 2.8 Q ₆ (cfs)	TOTAL DISCHARGE Q _T (cfs)
				"C"	Q ₄ (cfs)		
157.6	-	-	-	-	0	-	-
158.6	-	-	-	3.48	120	-	120
159.6	-	-	-	3.67	360	-	360
160.6	-	-	-	3.72	680	-	680
161.6	-	-	-	3.83	1,070	-	1,070
162.7	0	-	0	4.00	1,610	-	1,610
162.8	40	-	30	4.00	1,660	-	1,730
162.9	130	-	70	4.00	1,710	-	1,910
163.0	230	-	130	4.00	1,760	-	2,120

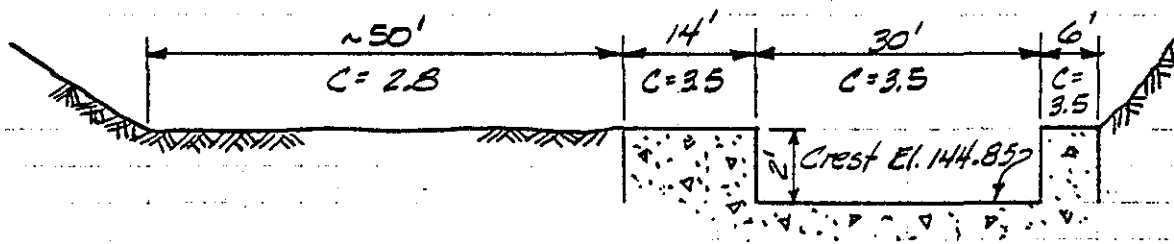
ELEVATION VIEW LOOKING D/S

Little Pond Dam

$$Q = CLH^{3/2} = 3.5 \times 30 \times H^{3/2} + 3.5 \times 20 \times (H-2)^{3/2} + 2.8 \times 50 \times (H-2)^{3/2} = 1,100$$

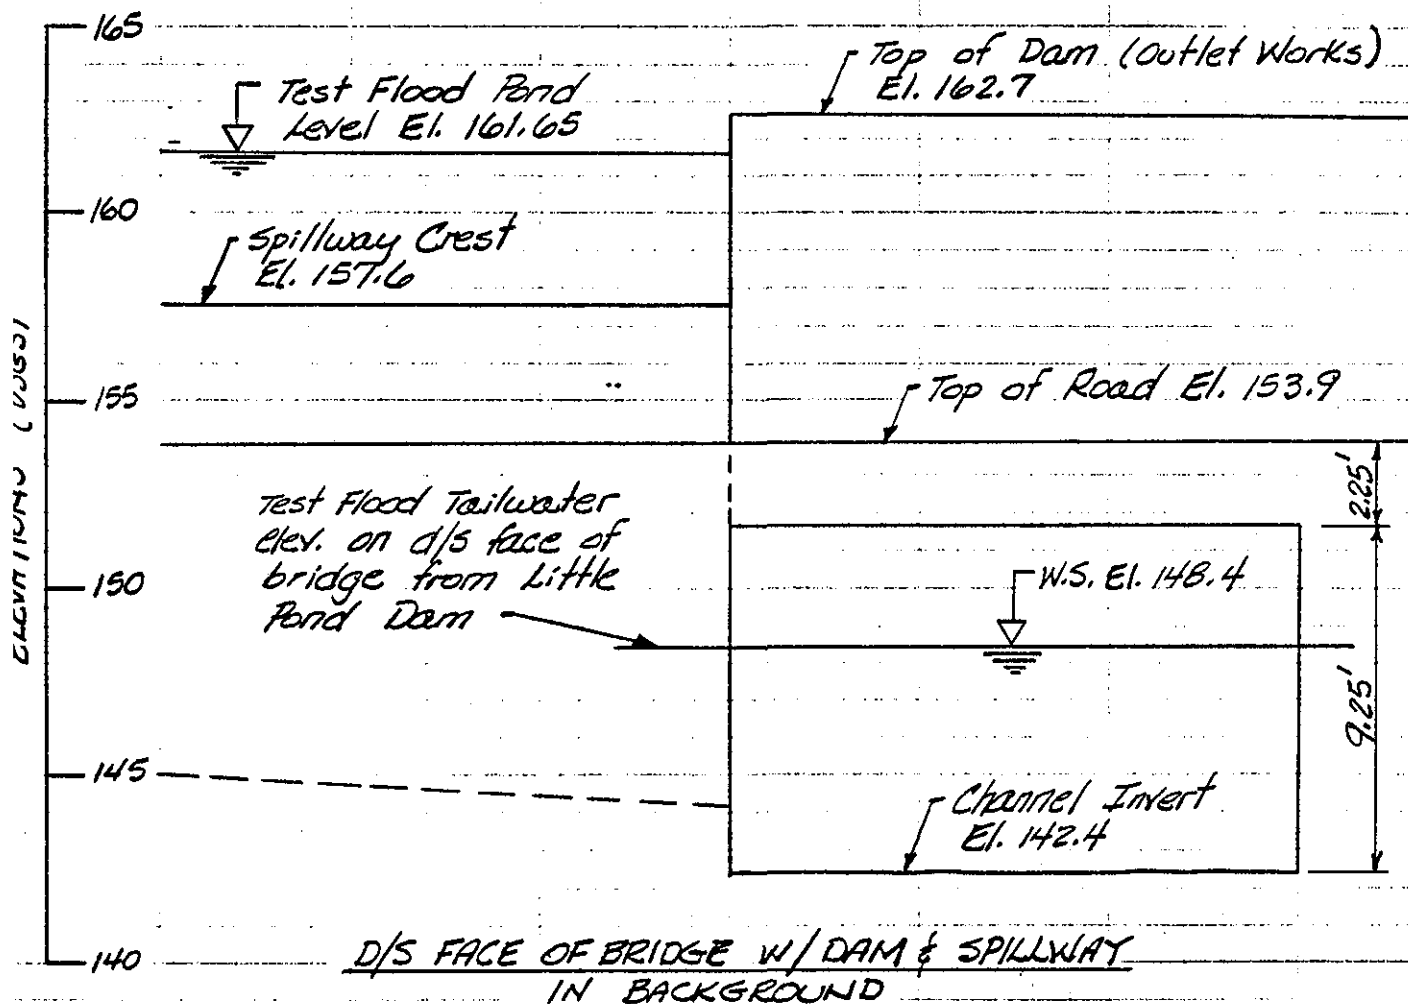
Then backwater elev. on d/s face of Chases Pond Road Bridge is El. 148.4

Approx. W.S. Elev. at u/s face of bridge:

$$Q = CA(2gh)^{1/2} \quad \text{where } A = 15' \times 9.25' = 138.75 \text{ s.f.}$$

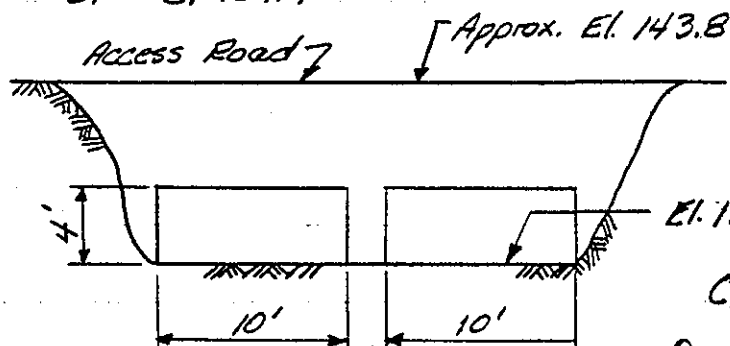
About 150 ft. d/s of Little Pond Dam is a gravel access road with a twin box culvert with invert about 10.5 ft. below crest of Little Pond Dam or El. 134.4

Effective Weir Length
 ≈ 100 ft.; $C_d = 3.0$

$$\text{Area} = 10 \times 4 \times 2 = 80 \text{ s.f.}$$

The dam failure outflow would overtop the gravel access road by about 5 ft. No structures would be affected nor is there any apparent potential for loss of life.

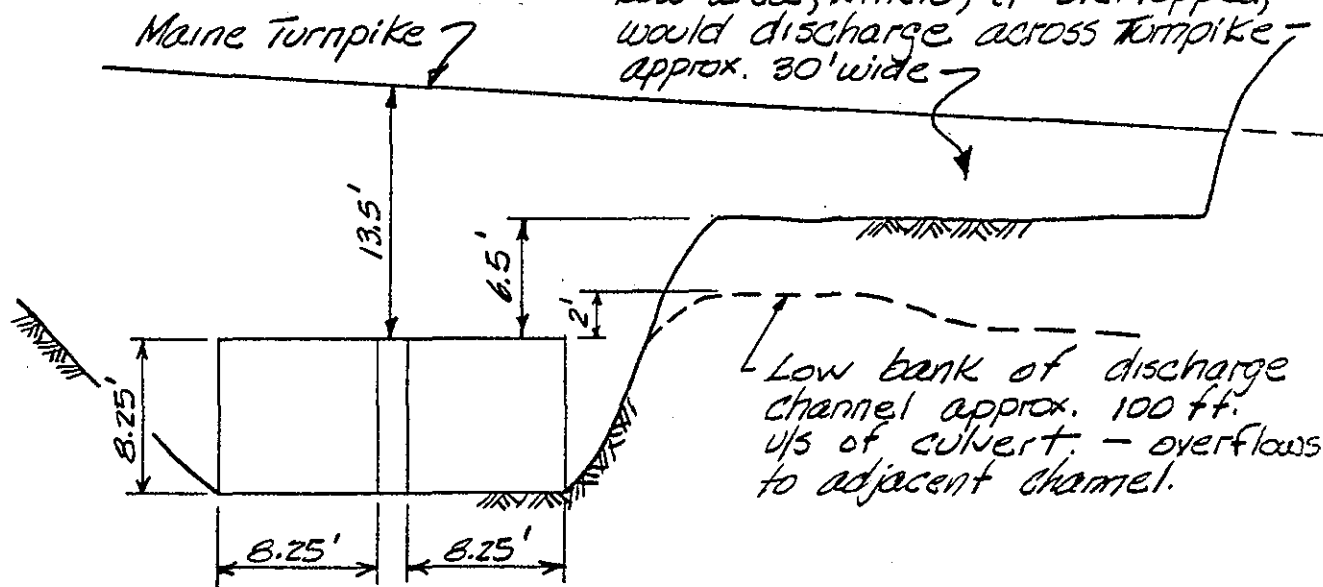
Low area, which, if overtopped, would discharge across Turnpike - approx. 30' wide

Low bank of discharge channel approx. 100 ft. U/S of culvert - overflows to adjacent channel.

If water depth = elev. of 30' wide bw area, $h = 4.1 + 6.5 = 10.6'$
